De Soto HOME INSPECTION Services

Home Inspection Report for

Property address: **123 Any Town USA**

Inspection date: **May 20, 2009**

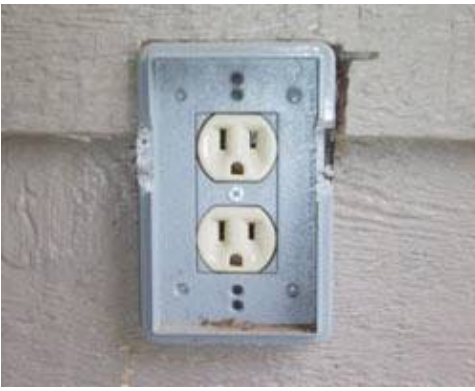
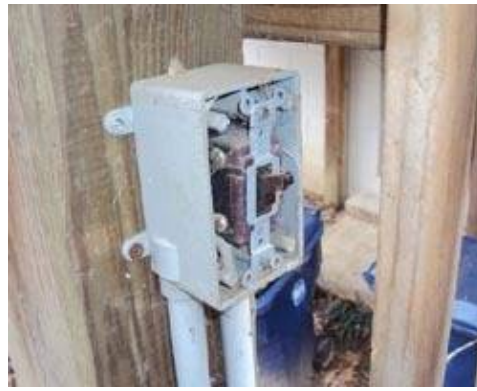
Exterior outlet(s) or switches were not waterproof. This can pose a safety concern due to the risk of fire and shock. Recommend installing waterproof covers where necessary.

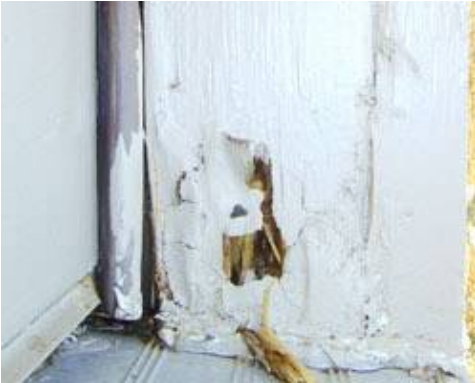
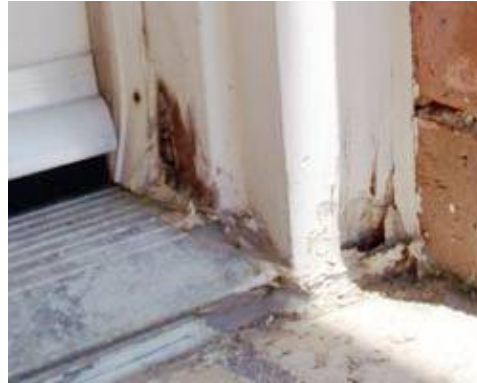
Back exterior door wood frame (brick molding) was damaged and/or deteriorating at the bottom of the frame. Recommend having a qualified contractor evaluate and repair or replace brick molding as necessary.

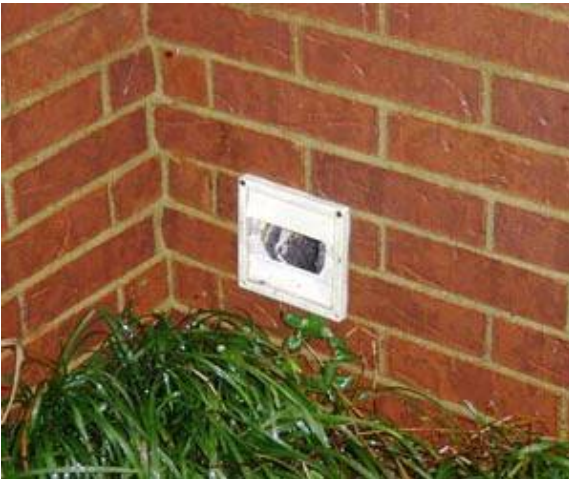
Photo 4

The end cap on the clothes dryer exhaust duct was damaged. Their purpose is to prevent air from entering the house through the clothes dryer, save energy, and keep out birds, rodents and bugs. Birds' nests can block the opening and are flammable. Recommend installing a new vent cap.

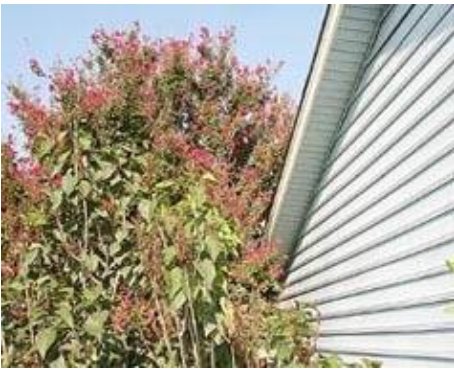
Photo 33

Tree(s) and shrubs were in contact with structure. Recommend pruning or moving tree(s) and shrubs so there's at least a one foot gap between them and structure.

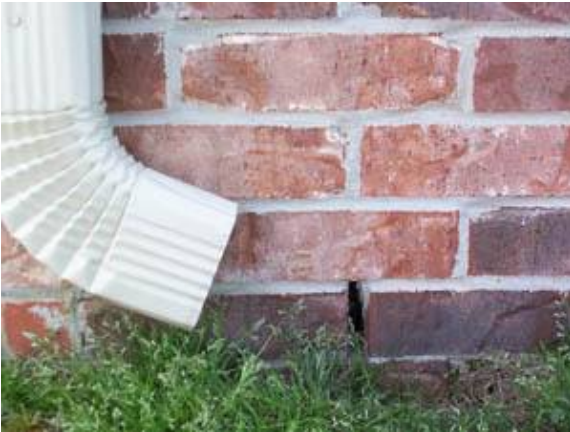
Photo 11

Downspout extensions were missing and/or ineffective. Recommend installing extensions such as splashblocks or a drain line where missing, or repairing where necessary so rain water is carried at least several feet away from the structure to soil that slopes down and away from the structure.

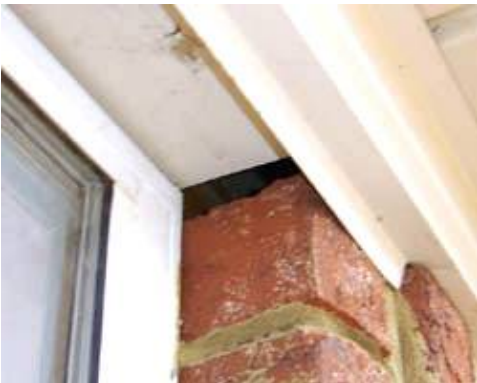
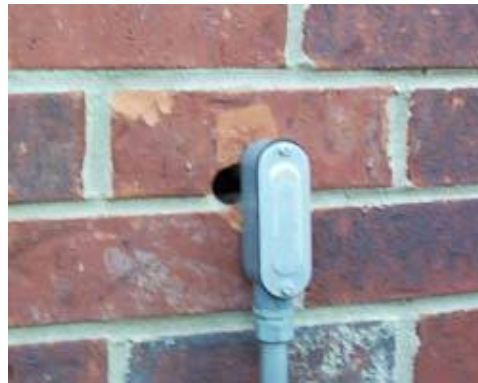
Caulking and sealing is needed around some areas of the home. Recommend caulking and sealing where necessary.

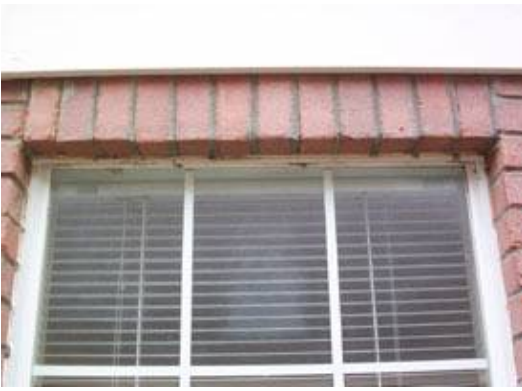
Photo 18

Missing lintel over window. A steel lintel is recommend over window's to support the brick above. The mortar is coming loose and the bricks are not properly supported. Recommend removing bricks over window, install a steel lintel for support, and reset the bricks in mortar.

This mistake was overlooked by the builder, mason contractor, and city code inspector.

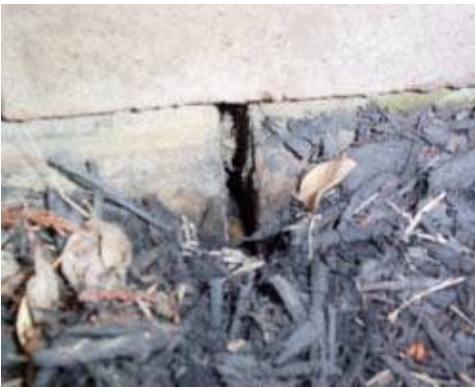
Photo 6

Flower bed mulch is piled over the weep holes in the brick veneer wall. Brick veneer walls absorb moisture. The wall is designed to discharge moisture with flashing and weep holes. When weep holes are obstructed they can create moisture problems to the structural of home. This condition leads to mold, mildew, termite infestation and deteriorating wood framing members. Recommend keeping all weep holes clear and un-obstructed from mulch and other debris.

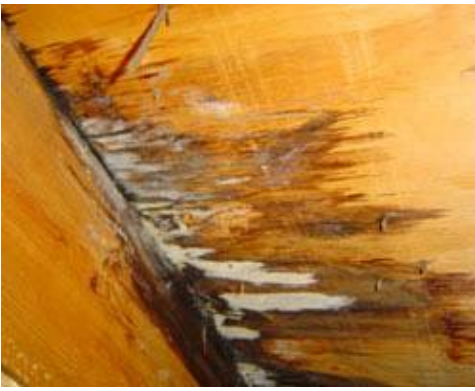
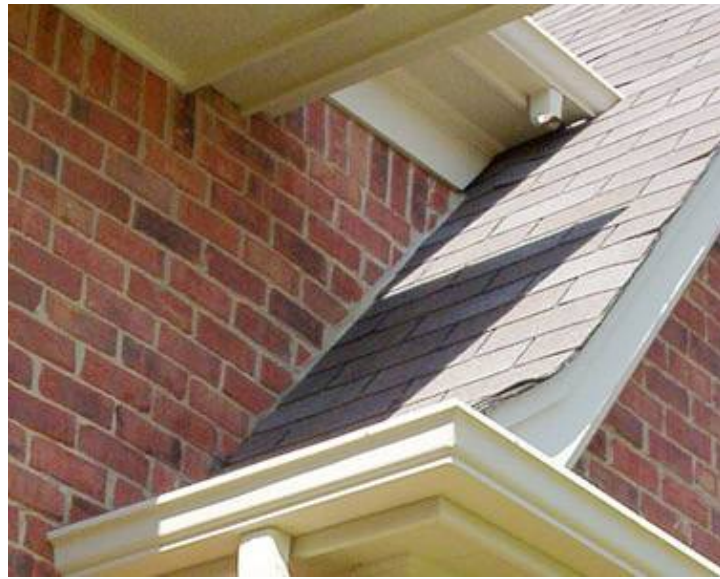
Flashing is missing in some areas of roof. Whenever shingles meet brick or any other siding, metal flashing is recommended to help prevent water from penetrating these areas. Recommend installing flashing were necessary.

This mistake was overlooked by builder, roofing contractor, and city code inspector. The damage shown was caused in just a short time.

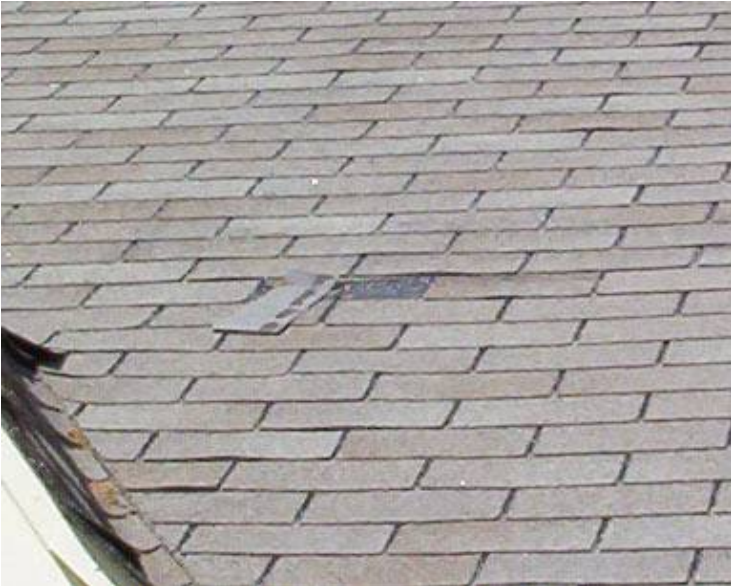
Photo 20

Noted missing and loose shingles during roof inspection. Recommend repair or replace shingles were necessary.

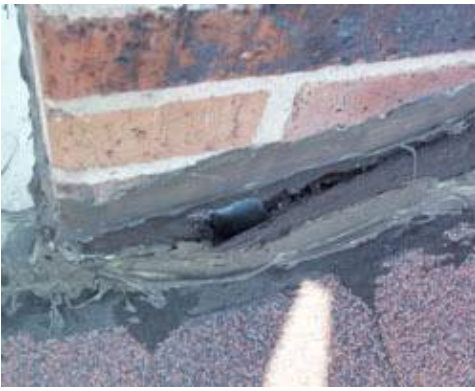
Photo 26

The chimney needs re-sealing around base. The tar is deteriorating and needs to be replaced.

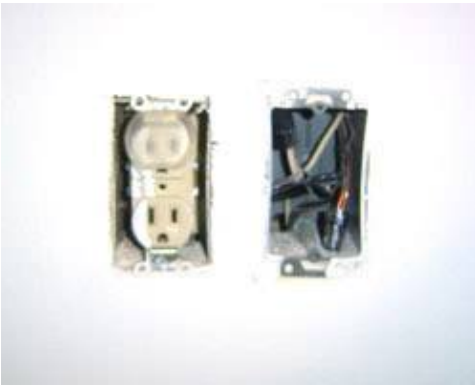
Photo 19

- 15) **+** Wire connections exposed due to no cover plates over one or more junction, switch or outlet boxes. Recommend installing cover plates where missing.

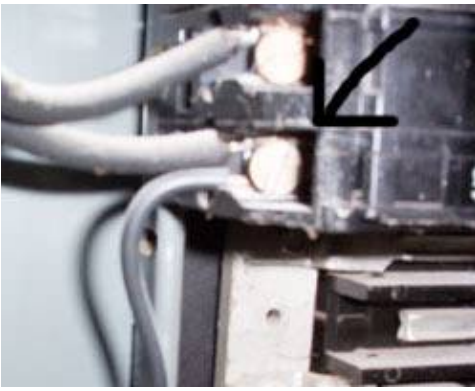
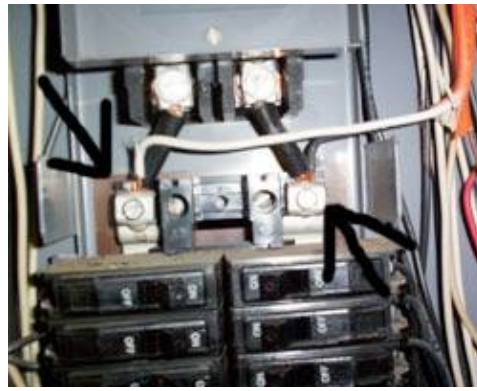
- 17) **+** One or more circuit breakers are "double tapped", where 2 or more wires are clamped in a circuit breaker terminal and the circuit breaker was only designed for 1 wire. This is a safety hazard since wires may come loose and cause arcing, sparking and fires. The photo on the right shows "tapping before the main" In other words, there's no over current protection provided for the circuit with the orange wires. This condition is much more of a safety issue than the double tap. Recommend having a licensed electrician evaluate and repair.

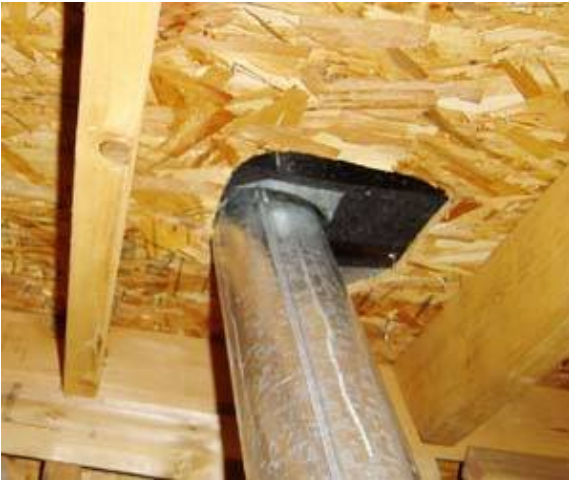
Photo 13

The vent pipe from the hot water heater is in contact with the roof's sheathing. The sheathing is a combustible material. The vent flue does reach high temperatures and can ignite the sheathing. Recommend cutting sheathing from the flue so there is at least a 2 inch clearance from all combustible materials by a licensed contractor.

This mistake was overlooked by the builder, plumbing contractor, and city code inspector.

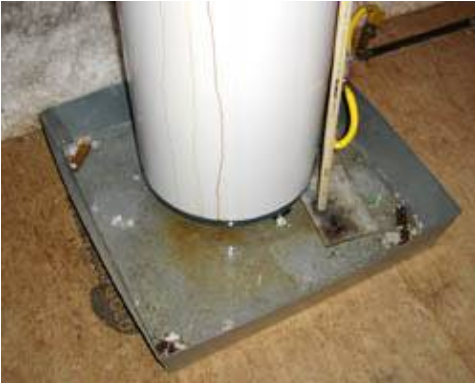
Photo 28

Temperature-pressure relief valve is leaking. Recommend having a licensed plumber replace valve.

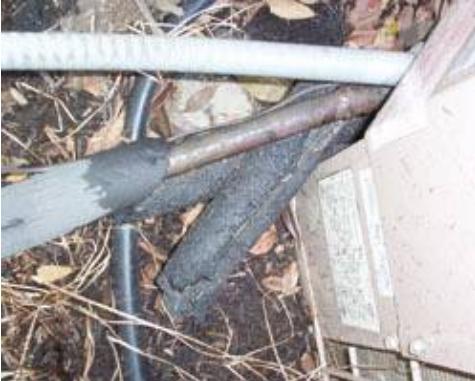
Photo 14

The insulation on the main line by the condensing unit is deteriorating and needs replacing. Recommend removing old insulation, cleaning lines and replacing with new insulation.

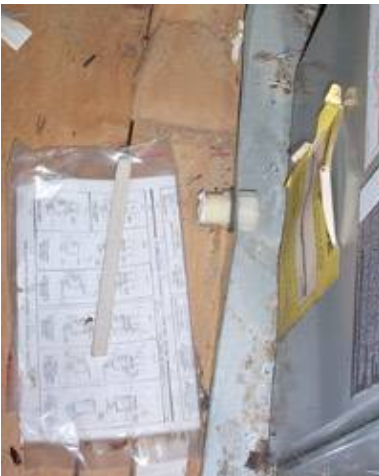
Photo 17

The drain line from the air handlers catch pan to the exterior is missing and was never installed. Water can now overflow pan and cause water damage. Recommend installing a drain line to the exterior of home.

This mistake was overlooked by the builder, heating and air contractor, and city code inspector.

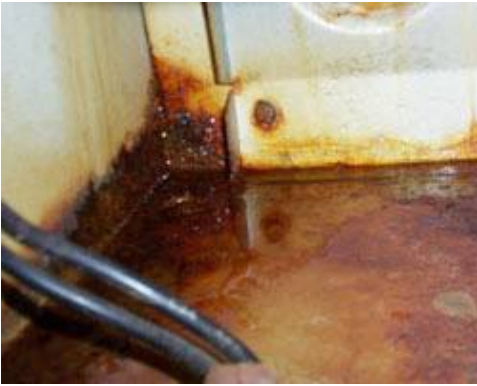
Photo 25

-
- 23) 🔍 Water from the evaporating cooler is leaking into the furnace. Rusting has occurred in this unit. The drain line is most likely clogged. Recommend further evaluation and repairs by a licensed heating and air contractor.

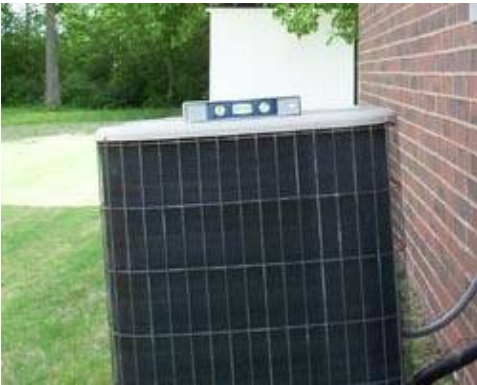
Photo 29

- 25) 🛠️ The condensing unit is not sitting level. The oil for the motor is more to one side and the motor is not being properly lubricated. This concern will lead to a short life cycle for the condensing unit. Recommend leveling this unit.

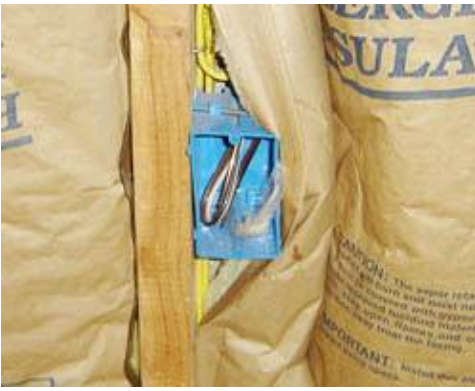
Photo 16

-
- 27) 🛠️ Wire connections exposed due to missing cover(s) over one or more junction boxes. Recommend installing covers over boxes where missing.

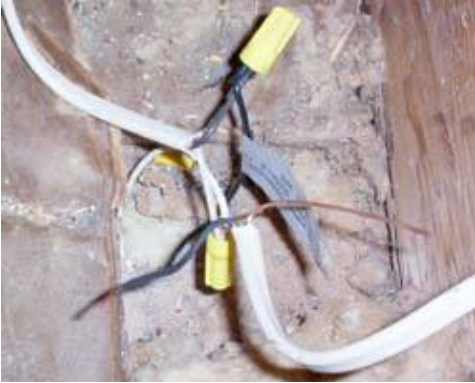
Photo 27

Exposed wiring due to splices not being contained in junction box. Some of the wires are also missing wire nuts as well. Recommend having a licensed electrician install wire nuts, and junction boxes with cover plates where needed to contain wiring splices.

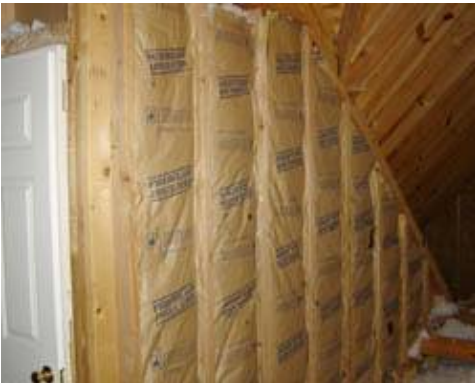
Photo 30

The roll insulation is installed backwards. The paper side (vapor barrier) should face the living side of home. The paper vapor barrier is a moisture barrier to prevent condensation concerns. Recommend removing installation and re-installing it correctly.

This mistake was overlooked by the builder, insulation contractor, and the city code inspector.

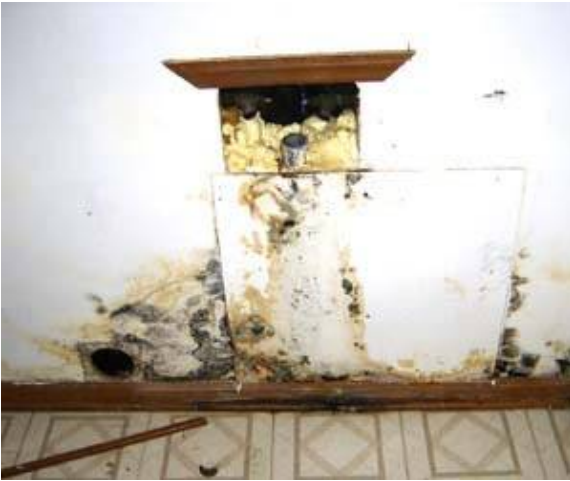
Photo 31

31) 🔧🔍 Leak found behind washing machine at the water hook up connections. This leak was most likely caused by the noted high water pressure. This leak has caused wall, floor and trim damage. Mold and mildew appears to have developed. Recommend repairs and further evaluation by licensed contractors.

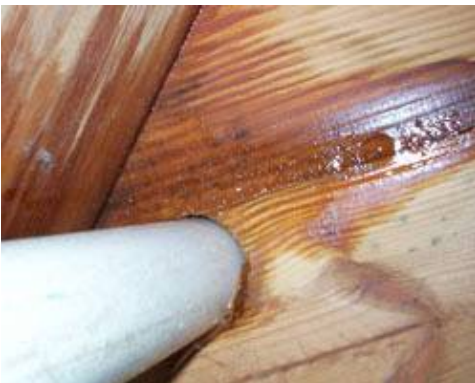
Photo 1

34) 🔧 Noted leak under hall bathroom during crawlspace inspection. Recommend repairing leak by a licensed plumber.

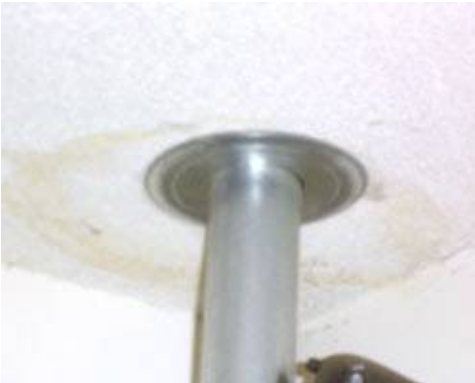
Photo 2

Water stains visible in ceiling. Ceiling material is wet, apparently from an active leak. Recommend repairing leak. Recommend removing wet wallboard or plaster and replacing with new after area has dried thoroughly.

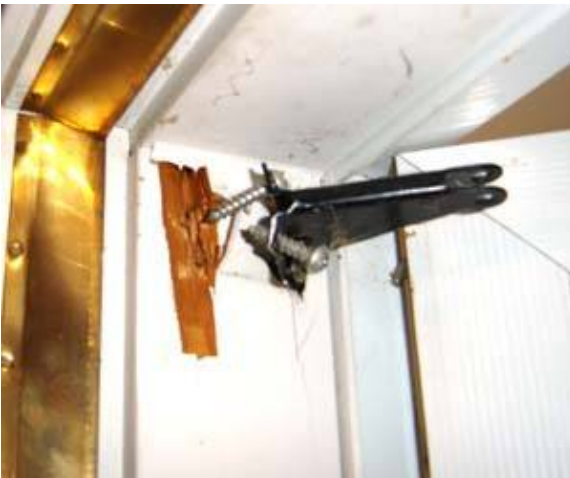
Photo 7

Hardware for the front security door has pulled loose from the door frame. The door frame is damaged. Recommend repairing hardware and door frame.
